Service Bulletin SB-4

June 22, 2004

This service bulletin describes a swage cracking problem in McFarlane Part Number MC600-72 and MC600-120 vernier mixture controls and requires removal and replacement of controls with an affected lot number. Non-compliance could result in loss of mixture control authority and subsequent loss of engine power.

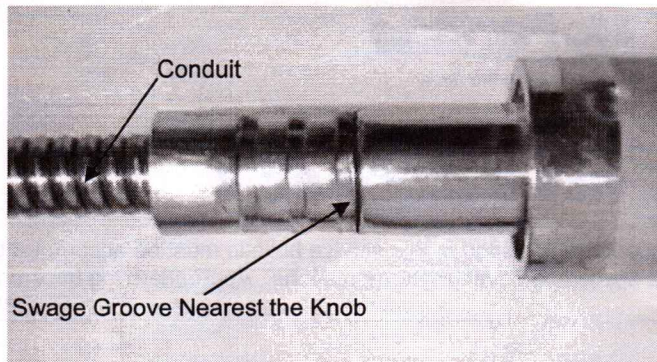
Figure 2: Close up of a swage joint.

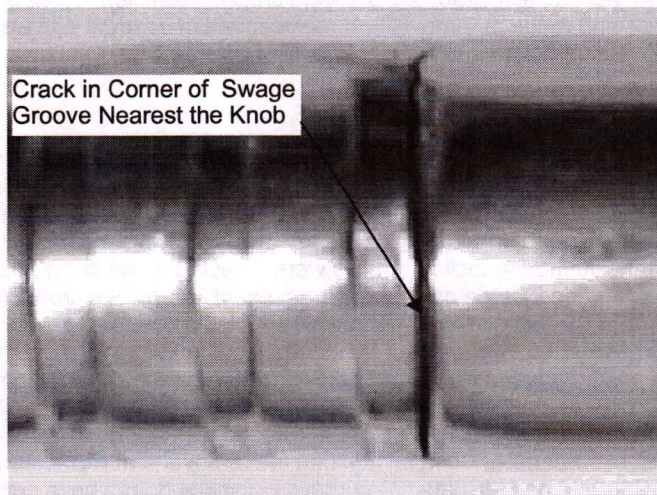
The cracks in the swage joint will not affect the functioning of the control in most cases, but in extreme cases involving unusual loading of the mixture control and complete detachment of the conduit from the housing, some loss or complete loss of mixture control authority could occur, although there have been no reports of service difficulties involving either of these part numbers. McFarlane Aviation has changed the design in the area of the swaged joint to prevent cracking in current production parts. Due to the difficulty of detecting the cracks, McFarlane Aviation is requiring the removal and replacement of all controls with the affected lot numbers even though many of the MC600-72 and MC600-120 controls in service do not have cracks.

Figure 3: Close up of a severe crack.

- 1) Remove the affected control from the aircraft.
- 2) Replace the affected control with a new MC600-72 or MC600-120 as applicable. Verify that the new control has a lot number greater than 11697. Install the new control per Drawing 1390 titled "McFarlane Aviation MC600 Series Solid Wire Vernier Fuel Mixture Control Installation Instructions" that is included with the new control or available from www.mcfarlaneaviation.com.
